EMERY COUNTY, UTAH - SURVEY MONUMENT RECORD

South 1/4 Corner of Section 35, T15S, R12E, S.L.B.&M. (Set Marked Stone)

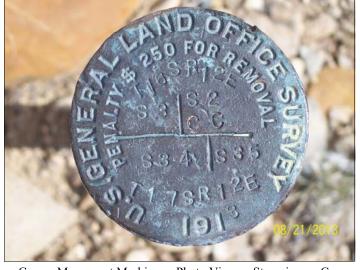
Corner Monument Markings - Photo View or Stamping on Cap

The monument for this Closing Corner is a 2.5" 1913 G.L.O. Brass Cap, on a 2" Iron Pipe, protruding ± 20 " above ground. This cap is incorrectly marked.

The Markings on this Monument are Incorrectly Marked for its Location.
