EMERY COUNTY, UTAH - SURVEY MONUMENT RECORD

DY LE OF UP SOUNTE OF U. SEC___8 __T____16S__ <u>R 12E</u>, <u>S.L.</u> B&.M. SURVEYED BY: S.V. DRAFTED BY: L.K.

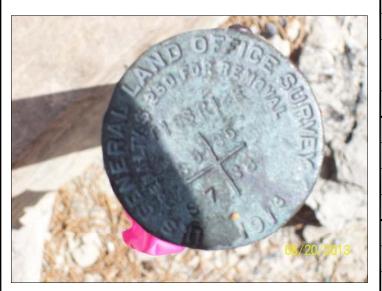
Corner Monument Markings - Photo View or Stamping on Cap

The monument for this Section Corner is a 2.5" 1913 G.L.O. Brass Cap, on a 2" iron pipe, protruding ± 2 ' above ground, within a pile of stones, ± 2 ' to the East of a T-Post.
