EMERY COUNTY, UTAH - SURVEY MONUMENT RECORD

SEC 8 T 16S R 12E, S.L. B&M.

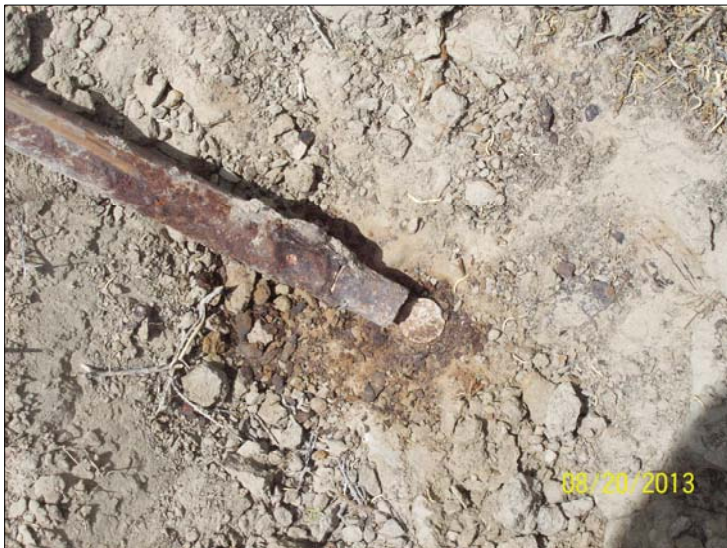
Corner Monument Markings - Photo View or Stamping on Cap

The monument for this 1/4 Section Corner is the base of a broken monument post, found Brass Cap laying next to the base. Used undisturbed base to establish monument location.
