EMERY COUNTY, UTAH - SURVEY MONUMENT RECORD

North 1/4 Corner
Section 8, T16S,
R12E, S.L.B.&M.
(Base of broken
monument post,
Brass Cap laying
next to the base)

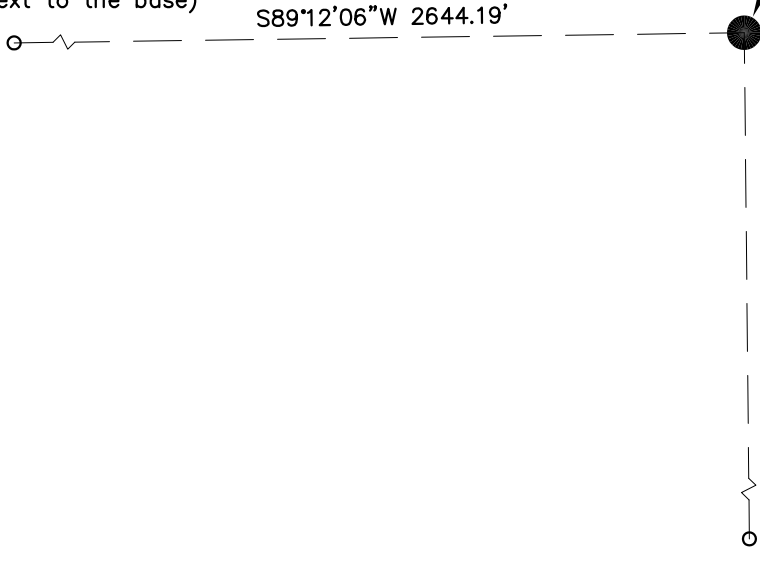
Date: 11-14-13
Not to Scale

SKETCH SHOWING RELATIVE LOCATION OF MONUMENT, ACCESSORIES AND REFERENCE POINTS STATING WHETHER FOUND OR SET.

The monument for this Section
Corner is a 2.5" 1913 G.L.O.
Brass Cap on a 2" iron pipe,
protruding ±1' above ground.
