EMERY COUNTY MONUMENT RECORD SHEET

PLSS Monument Preservation Sheet

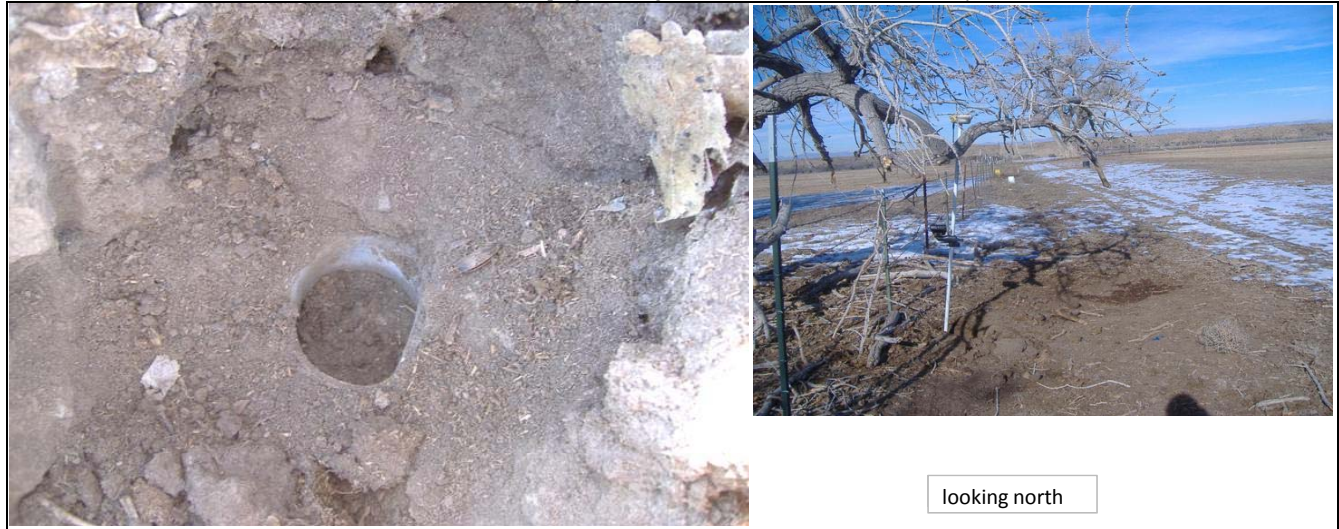
Sketch/Rubbing or Attach Photo of GPS Station Occupied
Show rotation of stampings/markings relative to North and describe briefly

found 2½" aluminum pipe in concrete (cap missing)

set #4 rebar: N 02°15'33" W, 28.41; N 01°30'12" W, 44.22; S 02°18'14" W, 17.41; S 00°47'15" E, 63.61
